Ruppin, Joerg Martin

Masur-Implantatzentrum Penzberg, Germany

5TH INTERNATIONAL CAMLOG CONGRESS
26TH – 28TH JUNE 2014, VALENCIA, SPAIN

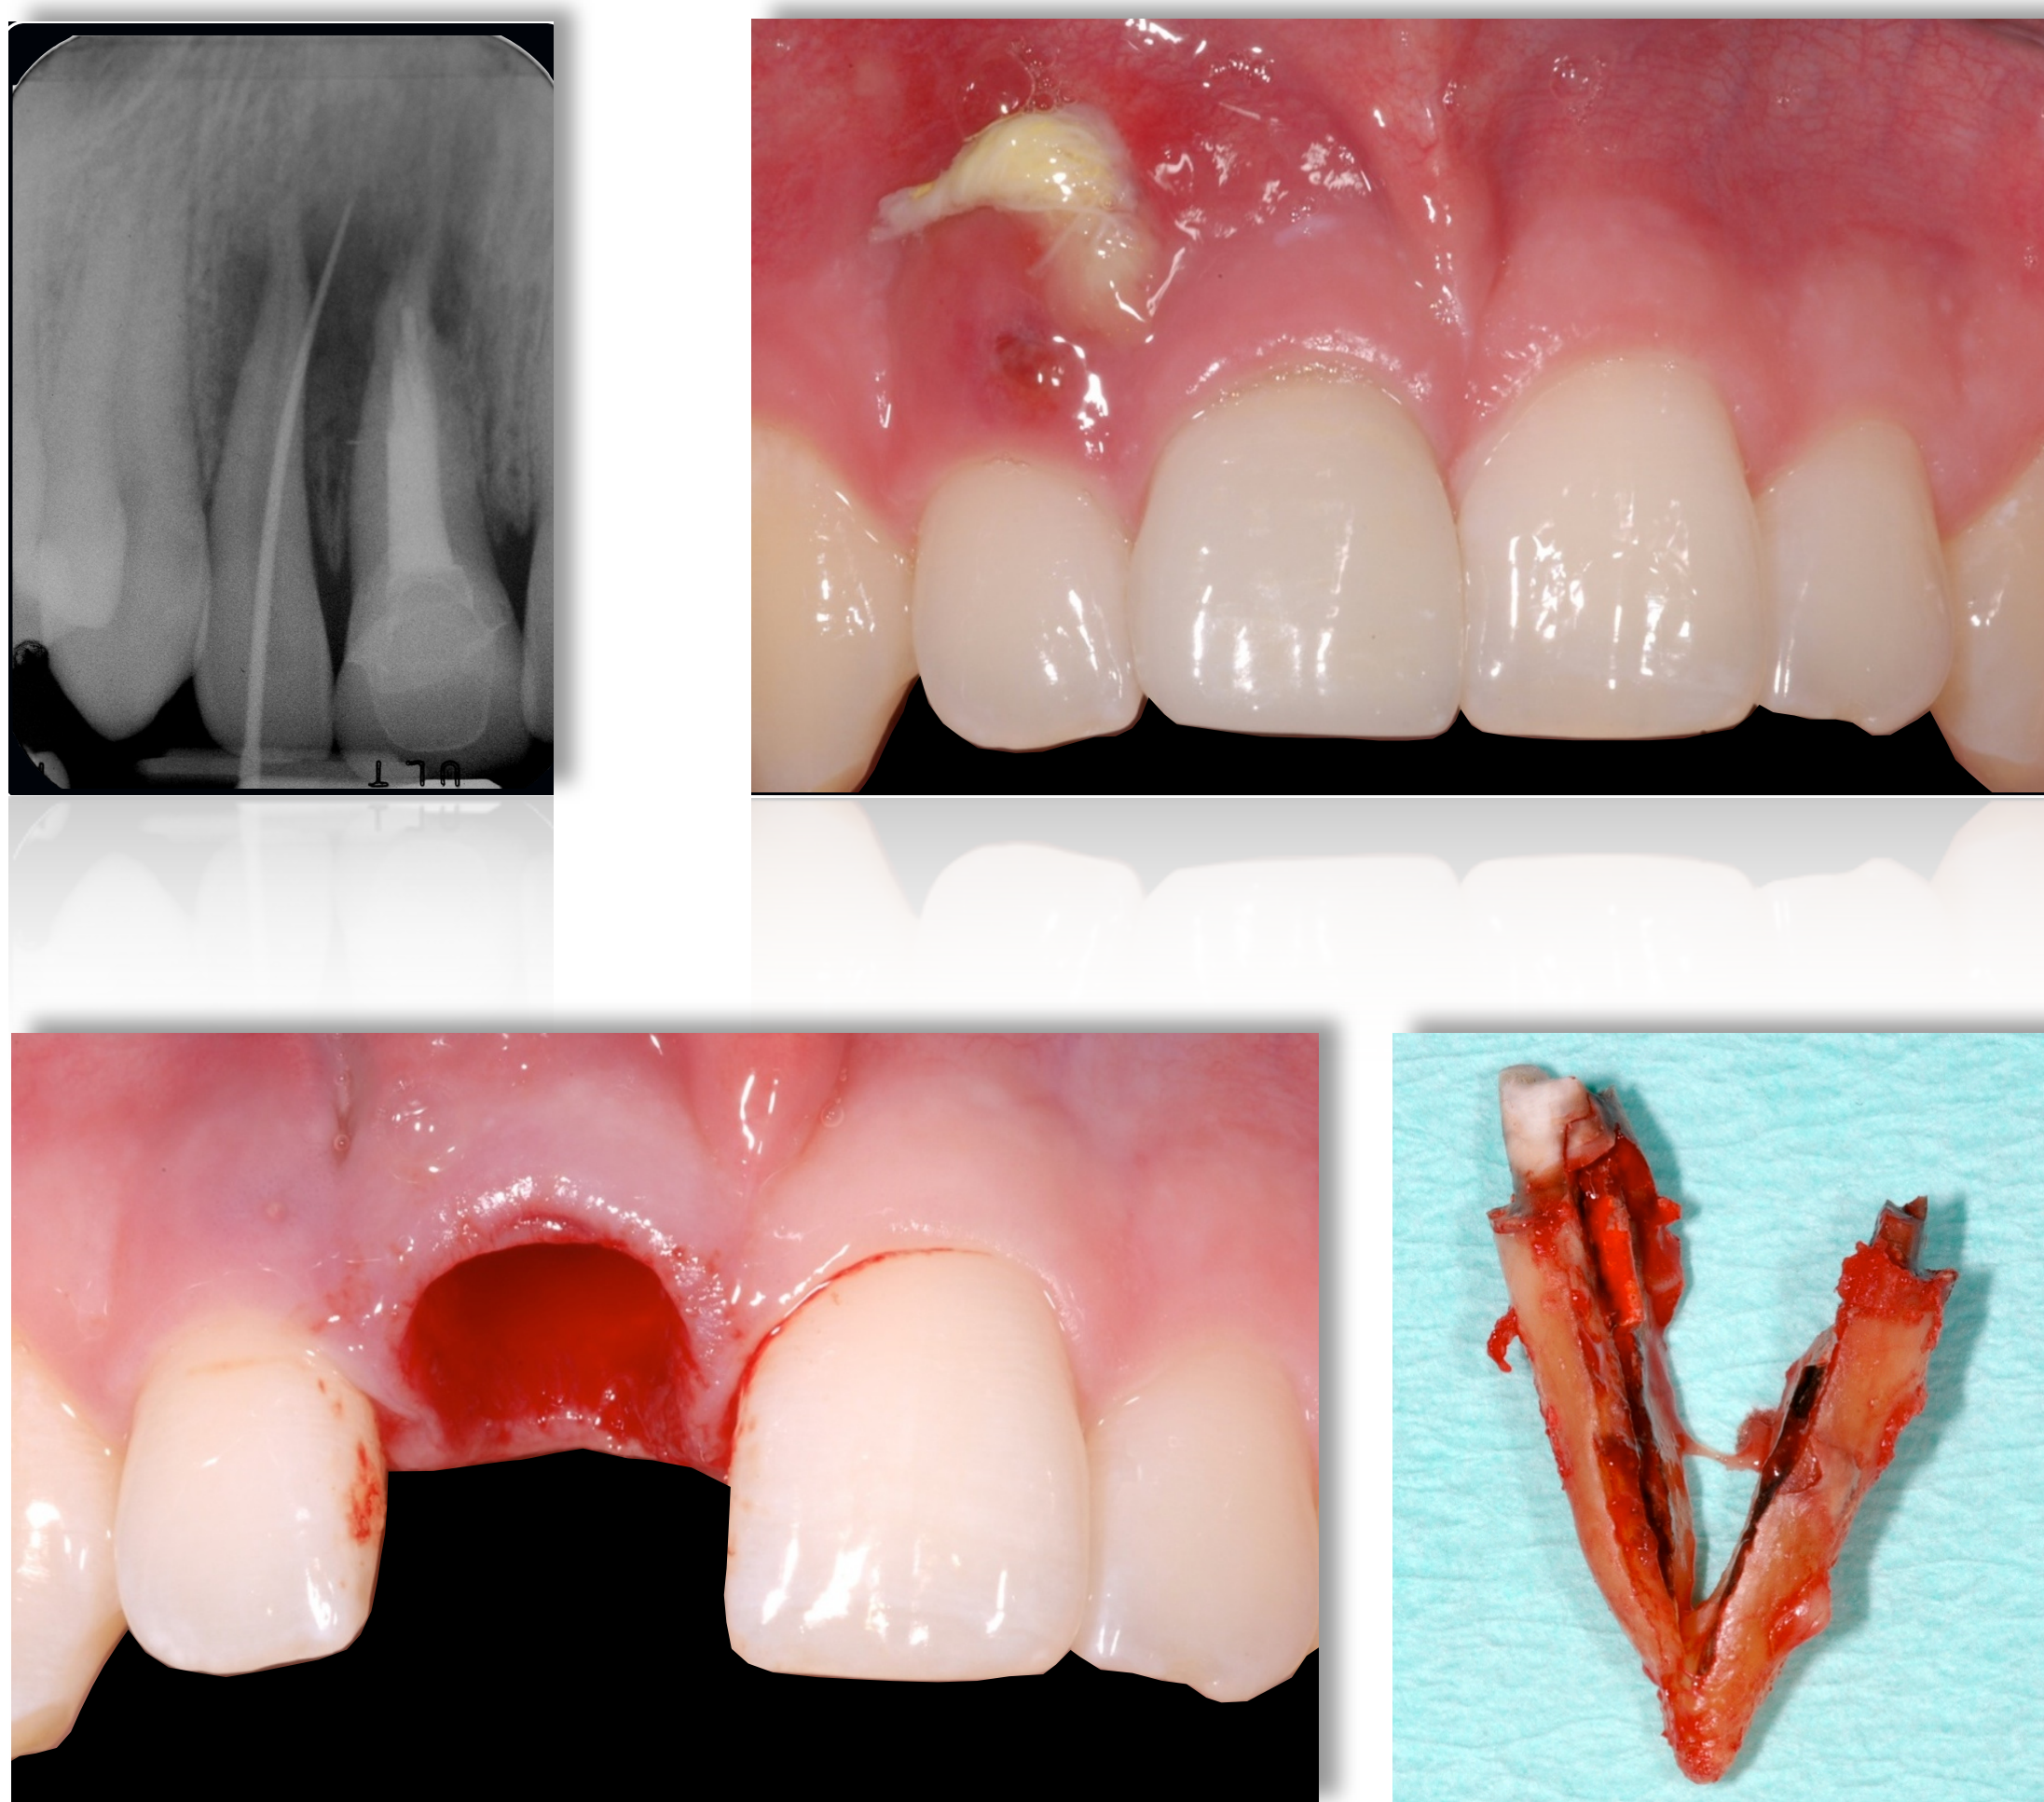
situation at beginning

The patient suffered trauma to his maxillary anterior teeth at nine years of age. As a result, apexification and then root canal therapy was performed and the tooth was restored with an all-ceramic crown.

In 2010, at the age of 21, the patient presented with an abscess in the maxillary anterior region. A periapical radiograph with a gutta-percha point in the fistula showed extensive bone loss spreading from the central to the lateral incisor. Although his lateral incisor was tender to percussion and mobile (grade 2), it responded to vitality testing.

A fracture down the long axis of the central incisor was diagnosed. The abscess was drained, then the tooth was removed carefully. When the socket was being debrided, it was apparent that the labial bone wall was missing completely. Accordingly, a four-stage regeneration-to-implant protocol was planned.

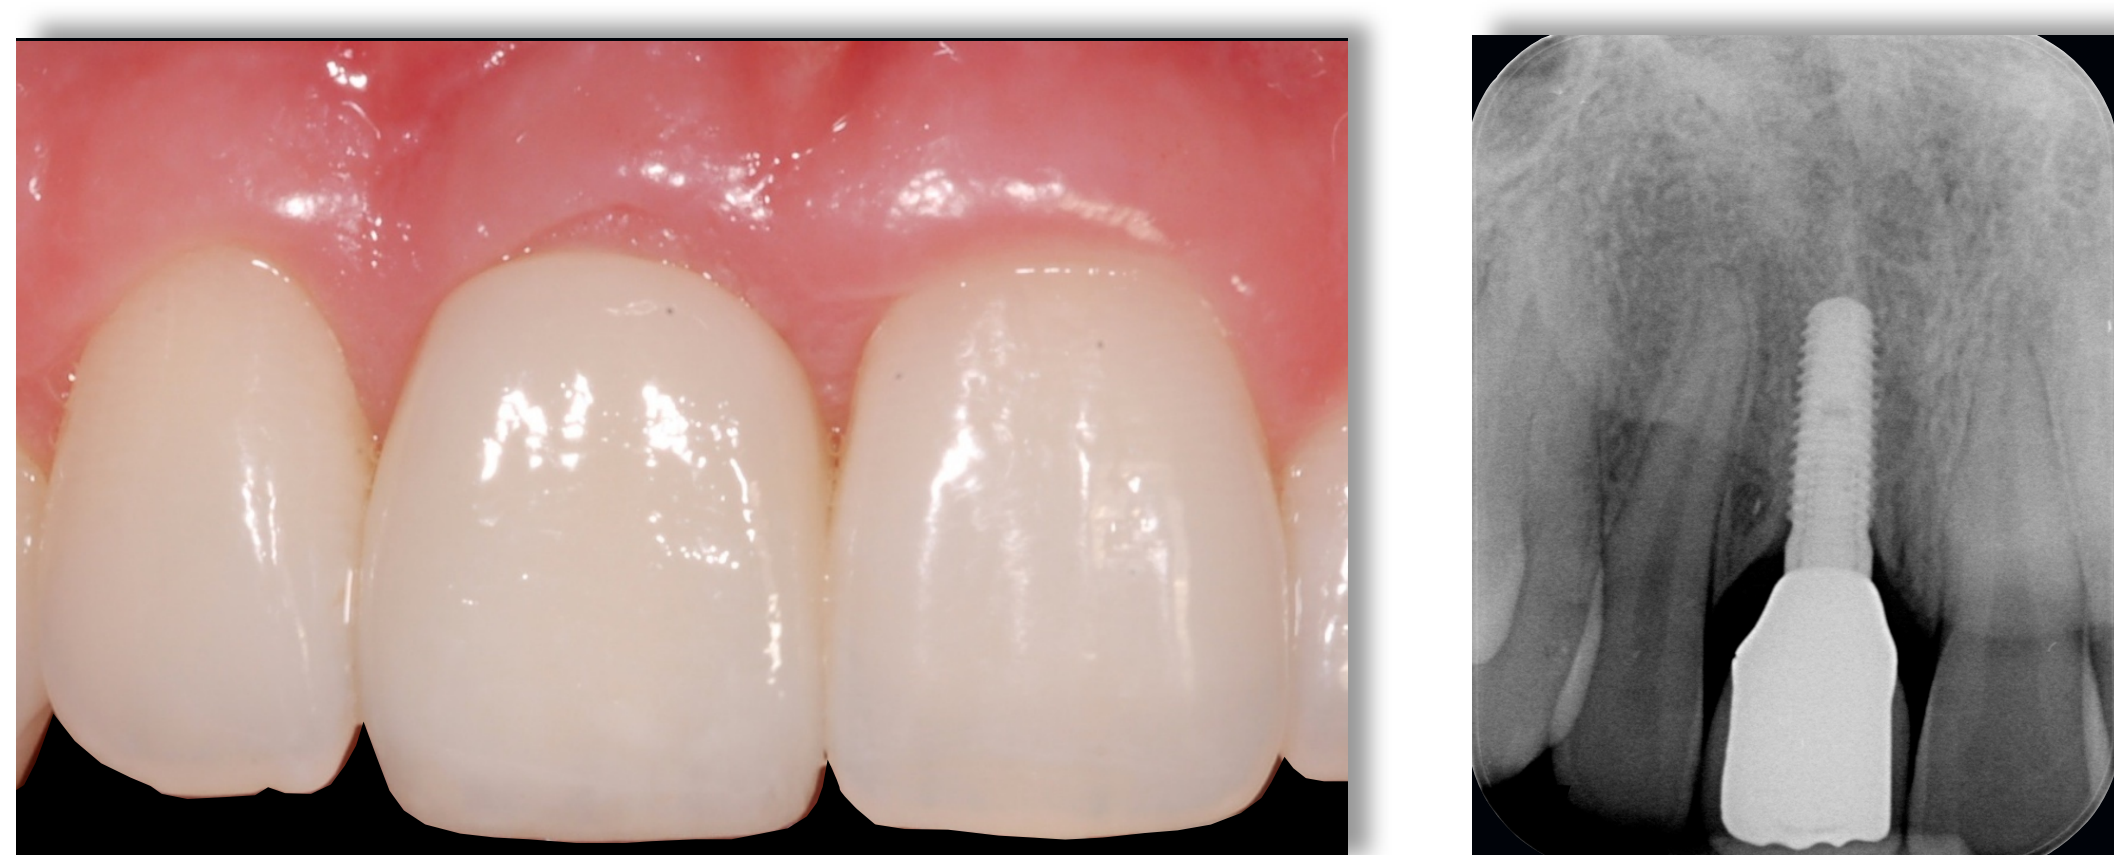
final result

Although the case took a considerable amount of time, and several procedures to bring to conclusion, a stable and aesthetic result was provided. Considering the poor situation at the beginning and the severe bone loss at the lateral incisor, re-establishing not only of a vital bone housing for the implant, but also achieving new periodontal structures for the lateral incisor was not an easy task. In the view of the author, results like this can only be achieved when using vital bone block augmentation.

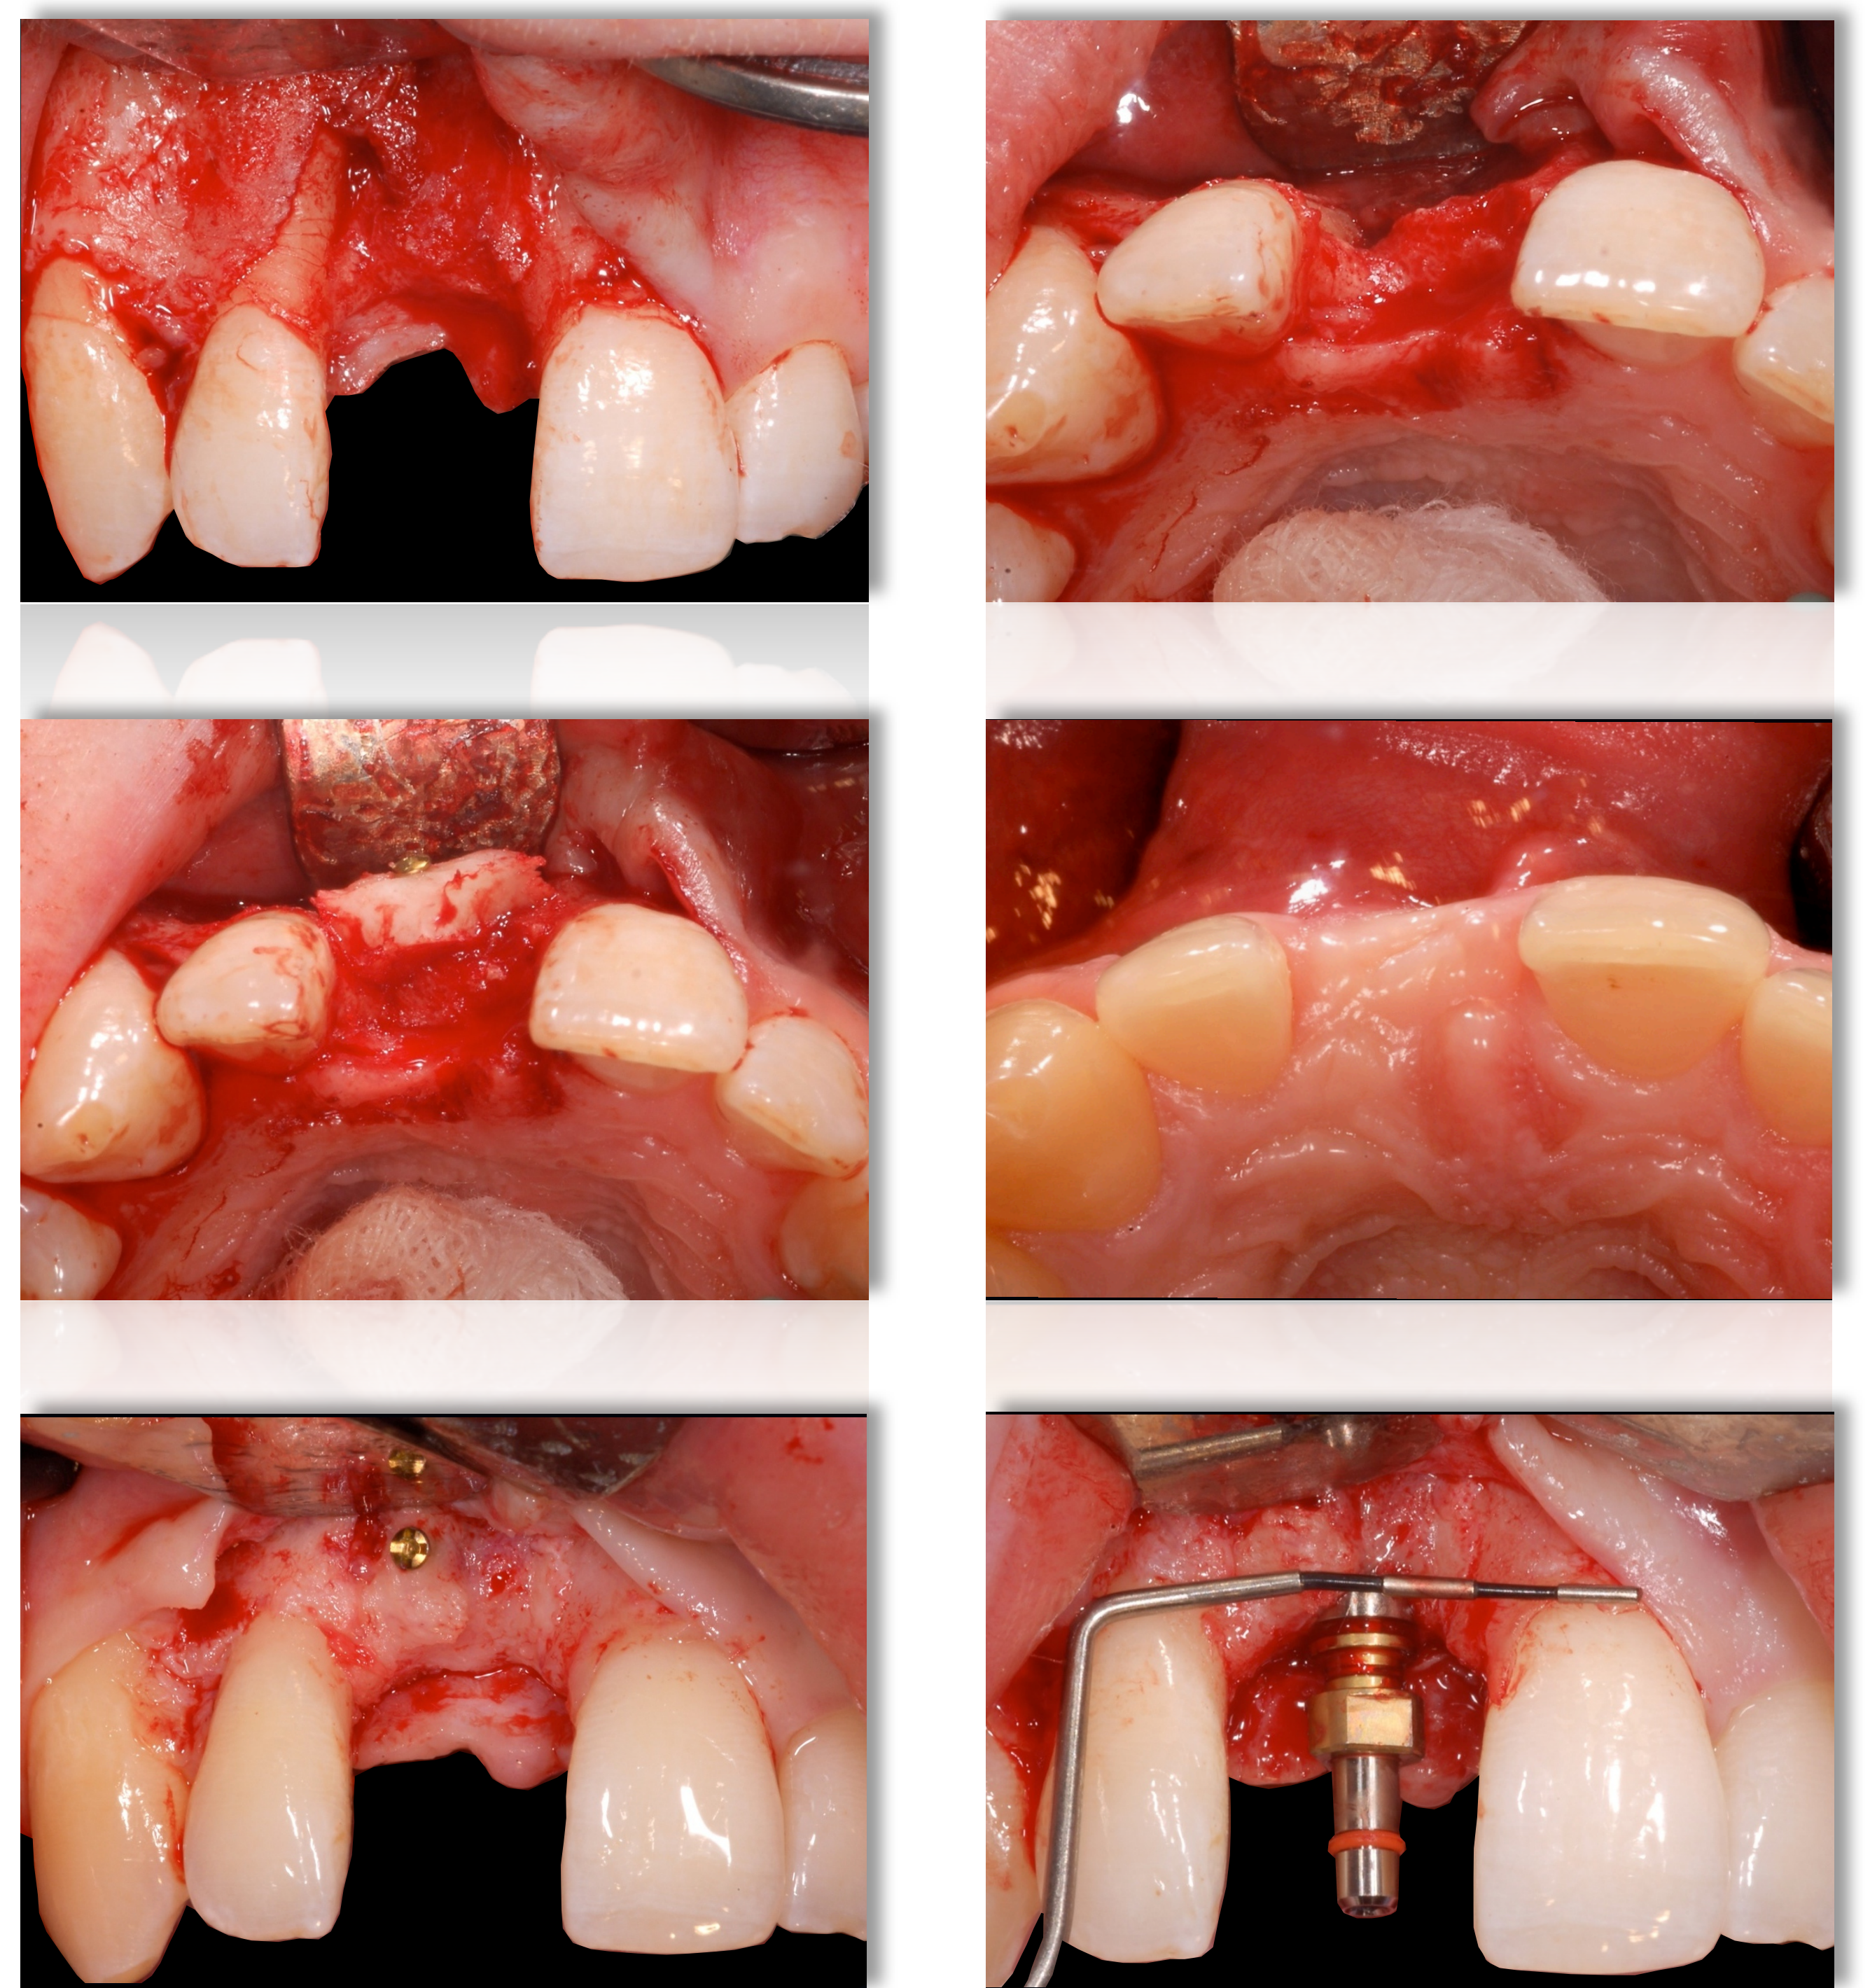
staged treatment plan

Stage 1. After the extraction and provision of a temporary prosthesis, the region was allowed to heal naturally for three months.

Stage 2. An autologous bone block taken from the mandibular angle was fitted in carefully and secured using micro titanium osteosynthesis screws.

Stage 3. Three months after the augmentation, a Camlog Screw-Line implant was placed. A subepithelial connective tissue graft taken from the palate was placed in the crestal region before primary soft-tissue closure over the implant was performed.

Stage 4. Three months later, the implant was exposed and progressive expansion of the soft tissue orifice was achieved by using a bottleneck gingivaformer, then a straight one and finally a wide body gingivaformer. This was followed by a final abutment and all-ceramic restoration.
